CASE STUDY

PROJECT SUMMARY

To safeguard the community's water supply, a NSW regional council undertook an upgrade of the raw water intake that draws from Billabong Creek.

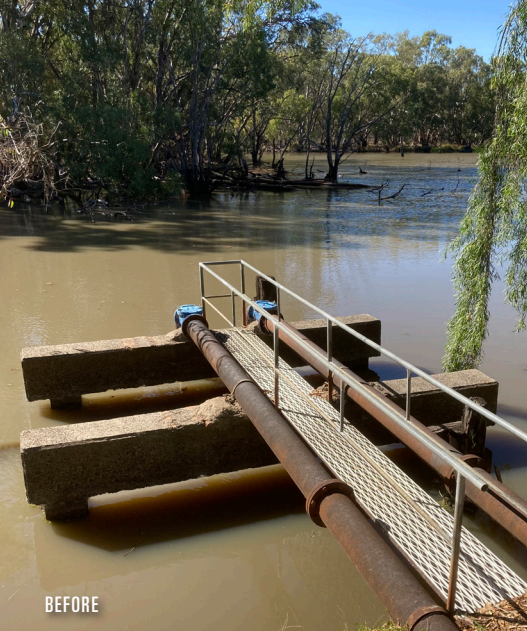
BEFORE

The existing intake arrangement consisted of two suction pumps drawing water directly from the creek, with a single 500-micron in-line filter providing the only means of screening solids and aquatic organisms.

The filter struggled with the high debris loads of sediment, seasonal vegetation and aquatic life. This led to frequent clogging resulting in up to one hundred backflush cycles per day, consuming excessive water and energy.

Operators were required to dismantle the filter housing and pressure-clean the unit, a time-intensive and repetitive task that consumed more than 1,300 hours of labour annually. The filter elements themselves were prone to damage, requiring full replacement approximately once per year at a cost of \$5,000.

When the system could no longer be sustained, the filter was bypassed altogether. This left the raw water supply unprotected, increasing the debris load to the treatment plant, reducing pump performance, compromising water

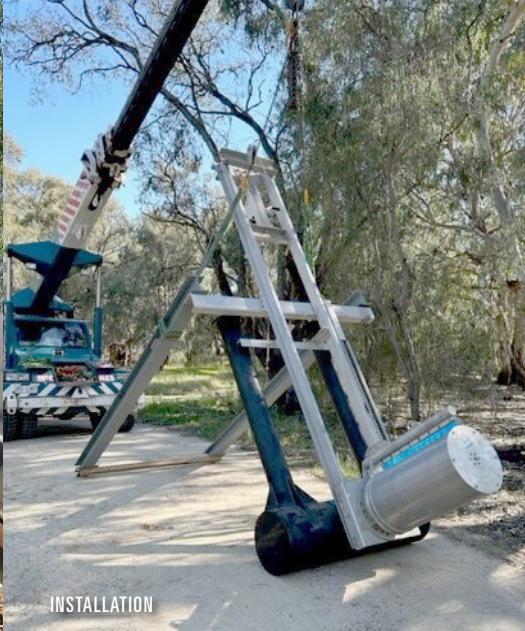
INSTALLATION

In response to the challenges identified, **AWMA installed a custom-designed, single self-cleaning cylinder screen for the raw water intake.** Fabricated from grade 316 stainless steel wedge wire, the screen medium is robust, durable and corrosion resistant. **The screen has a 1mm aperture, designed to process up to 12ML/day, with a low approach velocity of less than 0.1 metres per second.** The screen design ensures efficient debris exclusion while protecting aquatic life in compliance with environmental regulations.

To accommodate the site's dual-pump configuration, a custom polyethylene manifold was supplied, integrating both suction lines into a single screened intake point. This bespoke component simplified the hydraulic arrangement and streamlined installation. A manual winch-operated retrieval system was incorporated, enabling safe and efficient access to the screen for inspection without the need for cranes, divers or confined space entry.

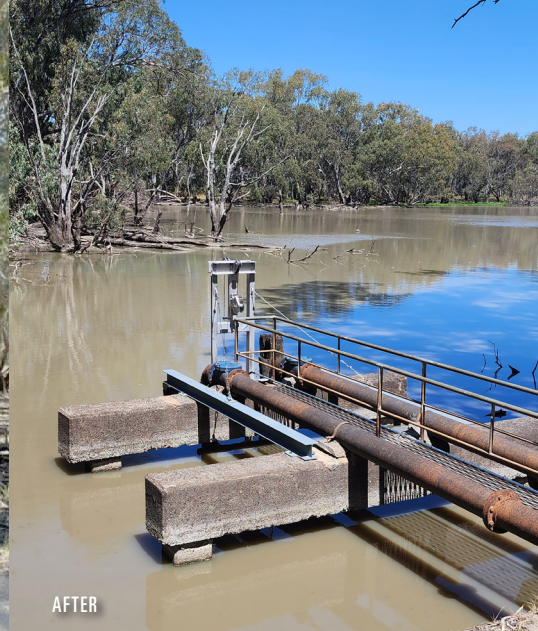
AFTER

The result was a robust, low-maintenance intake solution tailored to the operational and environmental requirements of a regional municipal water supply.
